## Test Intention:

In test 5034 we want to investigate the lifespan of our new CF29.25.15.02.01.D on the short way.

Series / No: CF29.D

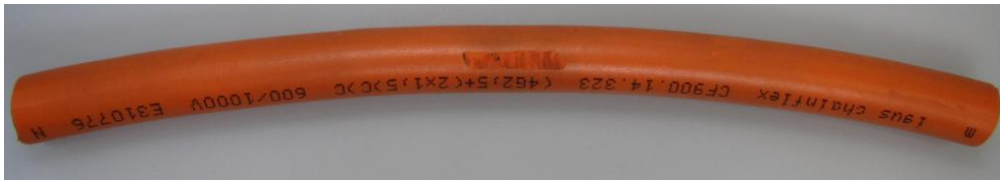
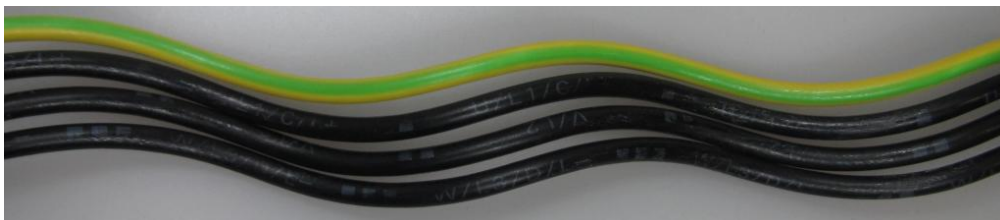
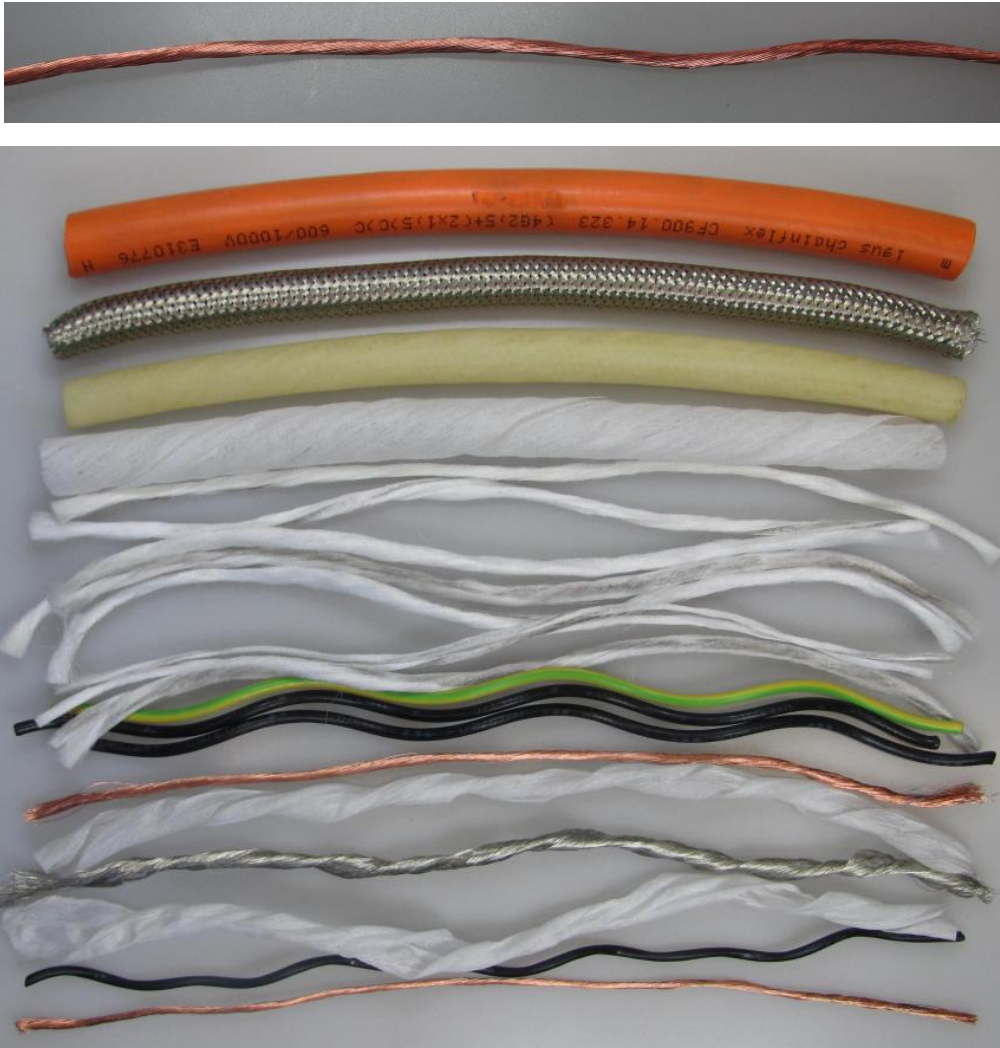
#### The condition of the cable no. 1.1 (CF29.25.15.02.01.D) after 15.159.234 strokes

At the 20.09.2016 we demounted the cable no. 1.1 after 15.159.234 strokes, because we wanted to investigate the condition of the cable.

Strokes	15.159.234
Condition outer jacket	O.K.
Condition overall shielding	O.K.
Condition inner jacket	O.K.
Condition banding material	O.K.
Condition centre element	O.K.
<b>Power cores 4G2,50mm<sup>2</sup></b>	
Condition core insulation	O.K.
Condition conductor	O.K.
<b>Element cores (2x1,50mm<sup>2</sup>)C</b>	
Condition element 1 <sup>st</sup> banding	O.K.
Condition element shielding	O.K.
Condition element 2 <sup>nd</sup> banding	O.K.
Condition core insulation	O.K.
Condition conductor	O.K.

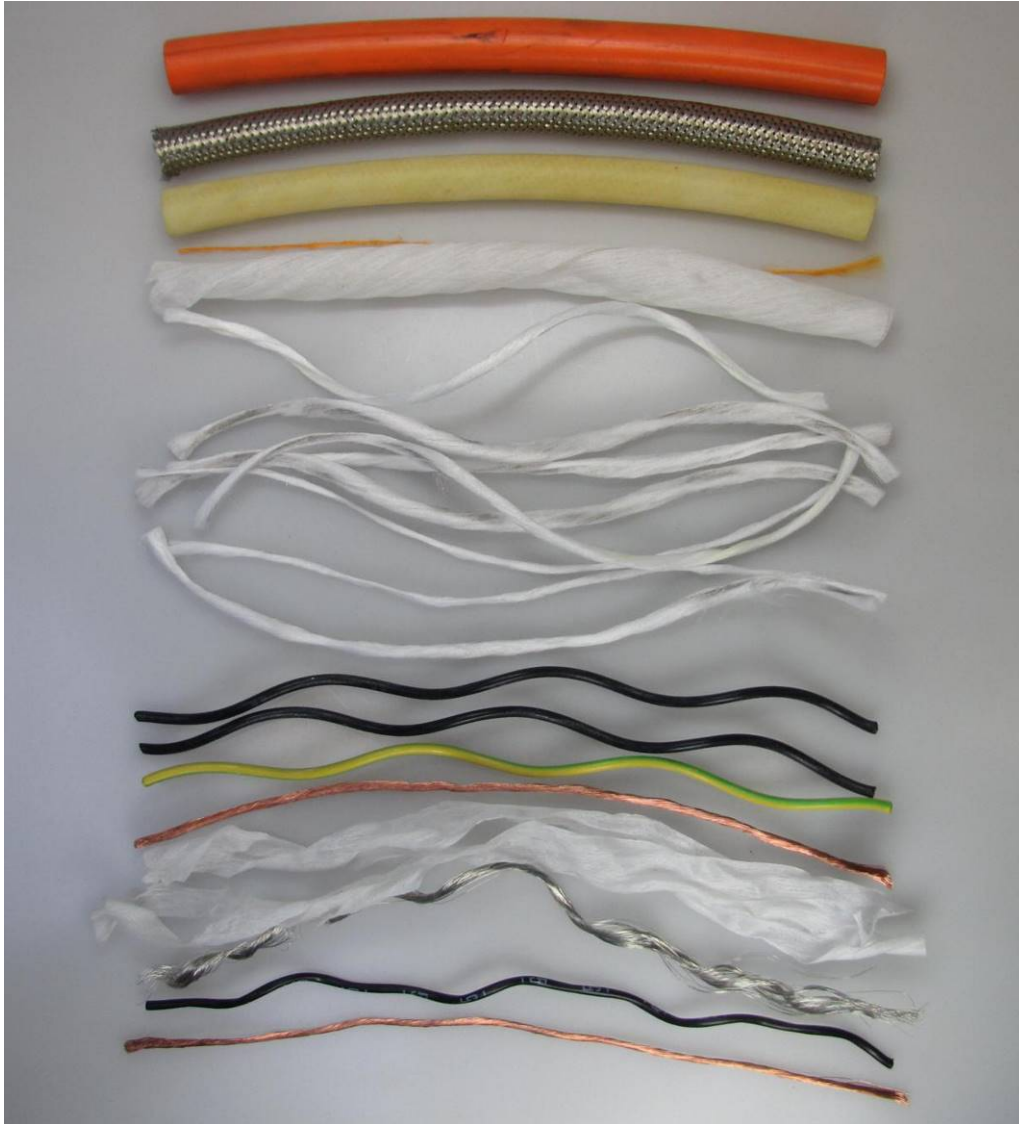
## The condition of the cable no. 1.2 (CF29.25.15.02.01.D) after 27.723.304 strokes

At the 28.06.2017 we demounted the cable no. 1.2 after 27.723.304 strokes, because we wanted to investigate the condition of the cable.

Strokes	27.723.304
Condition outer jacket	O.K.
Condition overall shielding	O.K.
Condition inner jacket	O.K.
Condition banding material	O.K.
Condition centre element	O.K.
Power cores 4G2,50mm <sup>2</sup>	
Condition core insulation	O.K.
Condition conductor	O.K.
Element cores (2x1,50mm <sup>2</sup> )C	
Condition element 1 <sup>st</sup> banding	O.K.
Condition element shielding	O.K.

Condition element 2 <sup>nd</sup> banding	O.K.
Condition core insulation	O.K.
Condition conductor	O.K.

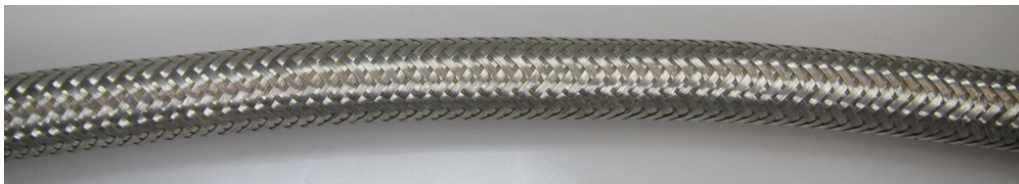
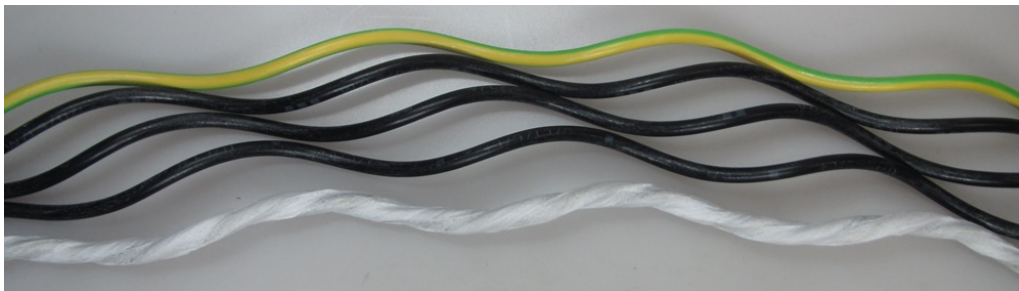
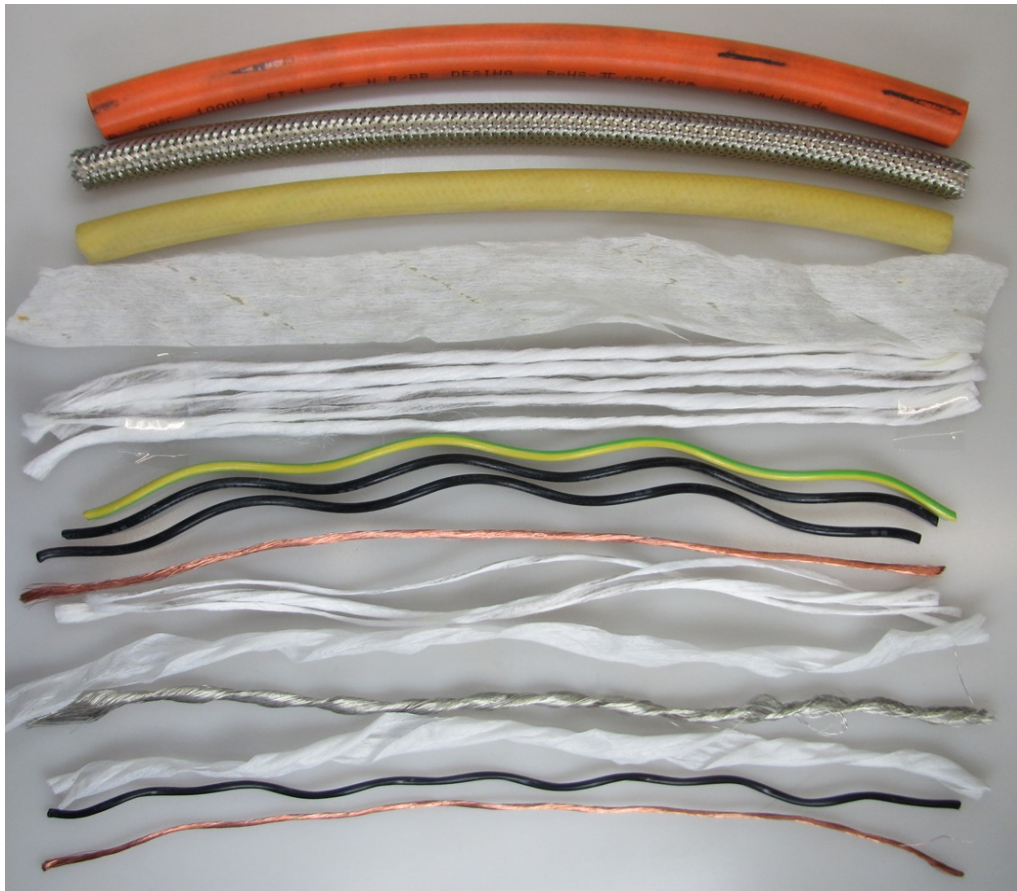
**The condition of the cable no. 1.3 (CF29.25.15.02.01.D) after 45.041.950 strokes**

At the 24.10.2018 we demounted the cable no. 1.3 after 45.041.950 strokes, because we wanted to investigate the condition of the cable.

Strokes	45.041.950
Condition outer jacket	O.K.
Condition overall shielding	O.K.
Condition inner jacket	O.K.
Condition banding material	O.K.
Condition centre element	O.K.
<b>Power cores (4G2,50mm<sup>2</sup>)</b>	
Condition core insulation	O.K.
Condition conductor	O.K.
<b>Element cores (2x1,50mm<sup>2</sup>)C</b>	
Condition element 1 <sup>st</sup> banding	O.K.
Condition element shielding	O.K.
Condition element 2 <sup>nd</sup> banding	O.K.
Condition core insulation	O.K.
Condition conductor	O.K.
