Test Intention:

In test 4588 we want to investigate the lifespan of CF880.10.12 in an e-chain with a 100mm radius.

Series / No: CF880

e-chain® type: E6.29.070.100.0

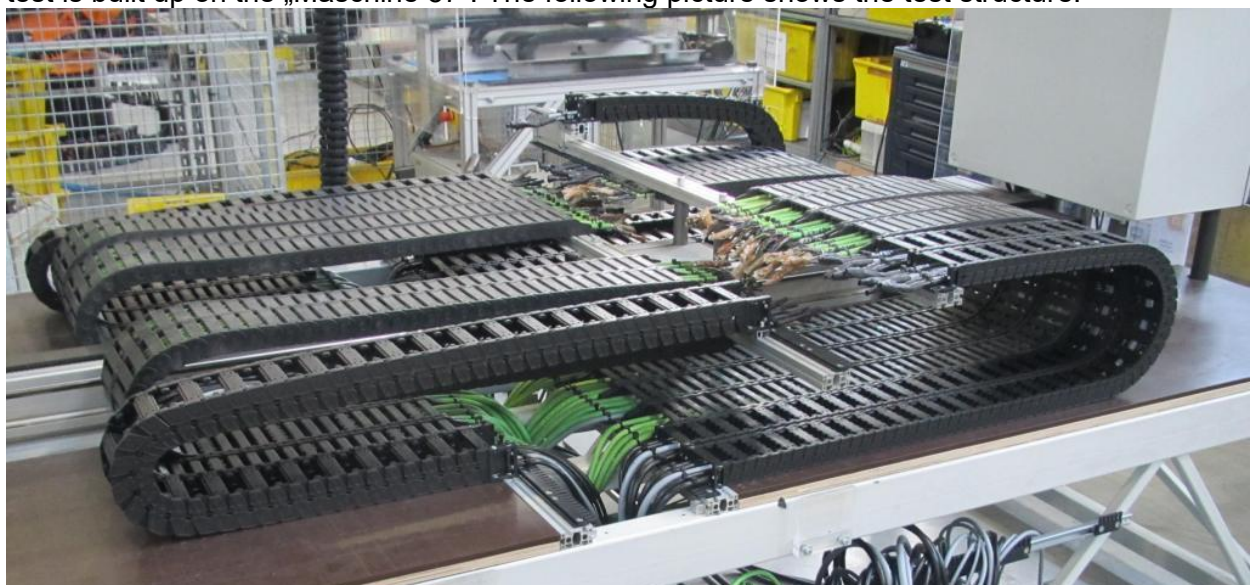
This test is built up on the „Maschine 57“. The following picture shows the test structure:

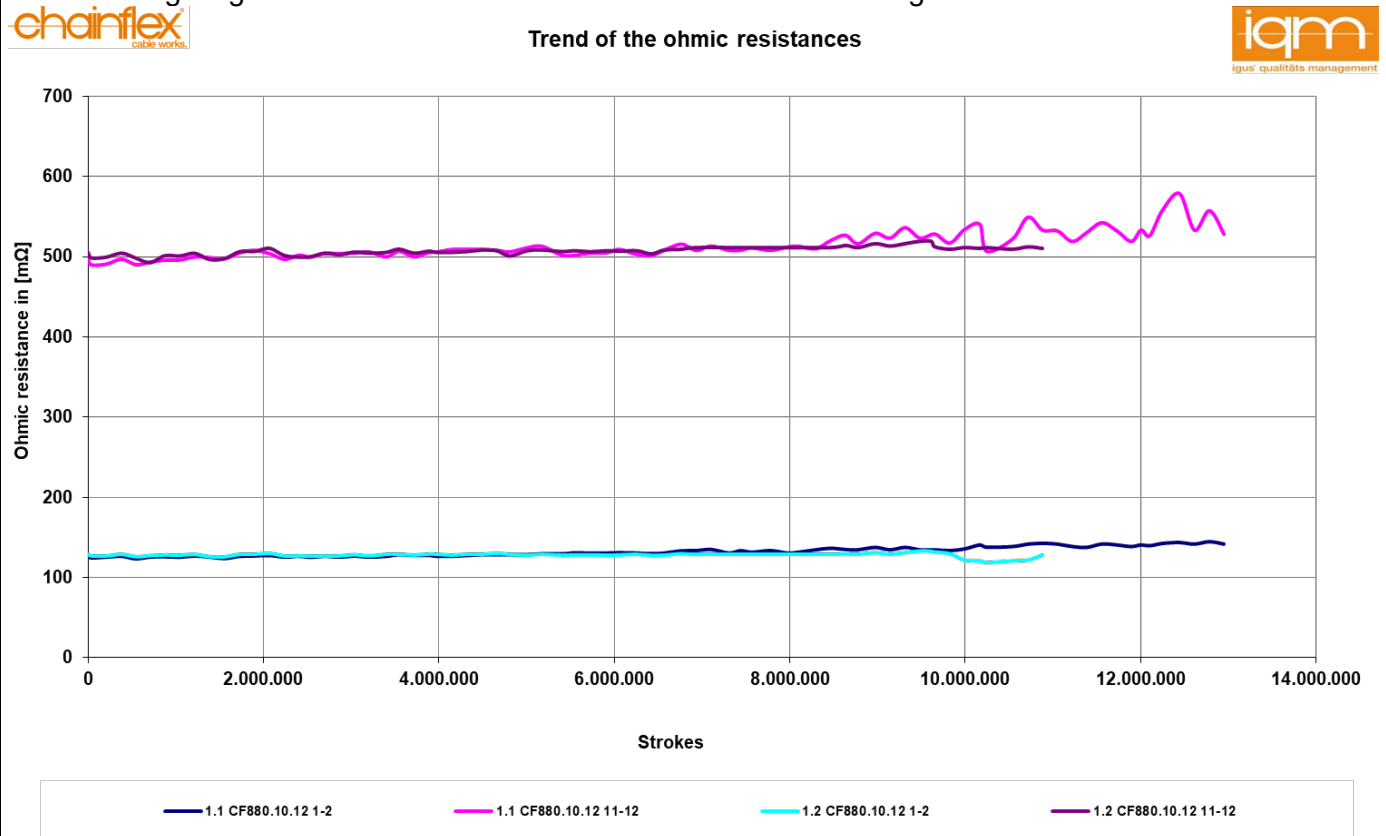
To detect broken conductor or shielding wires we will measure the ohmic resistance of these cable elements. The cores of the samples are connected in series to measure the ohmic resistances.

The following diagrams show the trend of the ohmic resistances during the test:

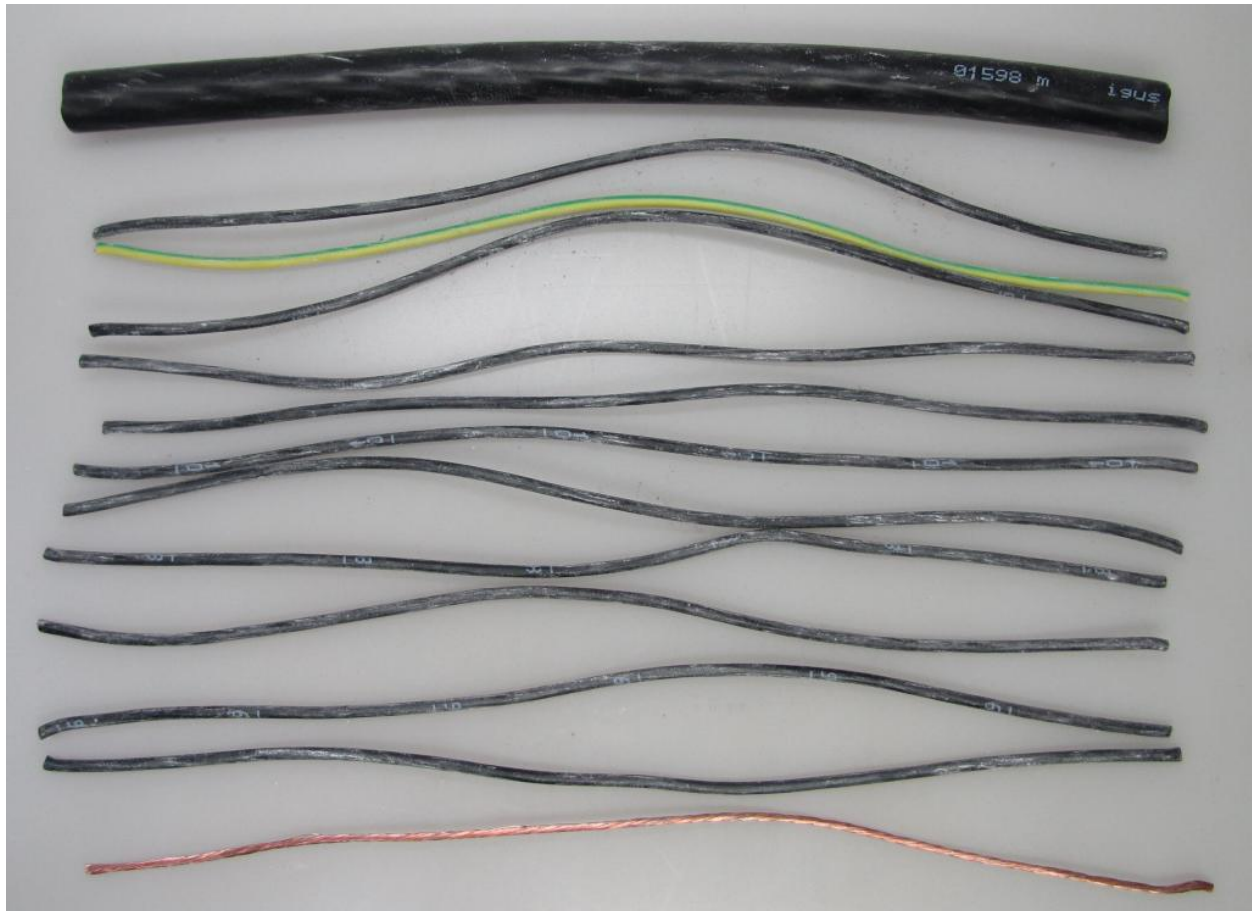
The condition of the cable no.1.1 (CF880.10.12) after 12.929.338 strokes

Strokes	12.929.338
Condition outer jacket	O.K.
Condition core insulation	O.K.
Condition conductor	O.K.

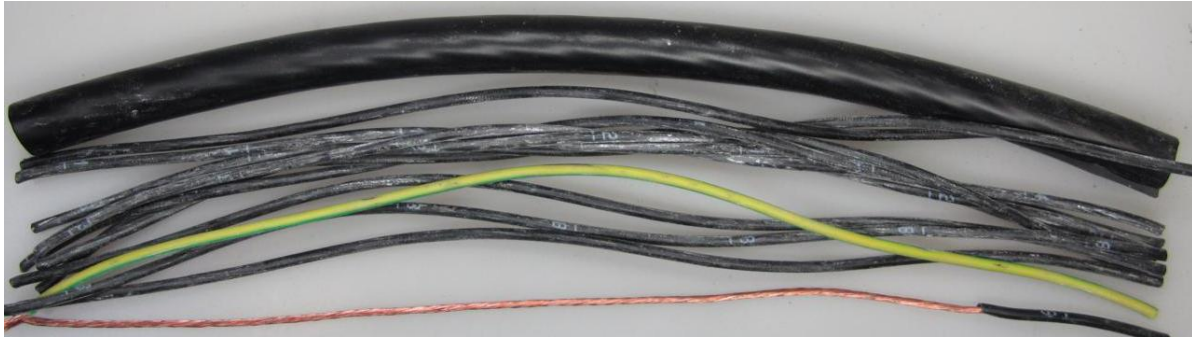
The condition of the cable no.1.2 (CF880.10.12) after 10.922.876 strokes

Strokes	10.922.876
Condition outer jacket	O.K.
Condition core insulation	O.K.
Condition conductor	O.K.
